Landslide monitoring and early warning

Ikuo Towhata
VP for Asia of ISSMGE
President of Japanese Geotechnical Society
Staying in Auckland with Seelye Fellowship

1. Recent slope disasters: **Izu Oshima** volcanic island
2. Mechanism of slope failure
3. Device for early warning
4. Difficulty in early warning

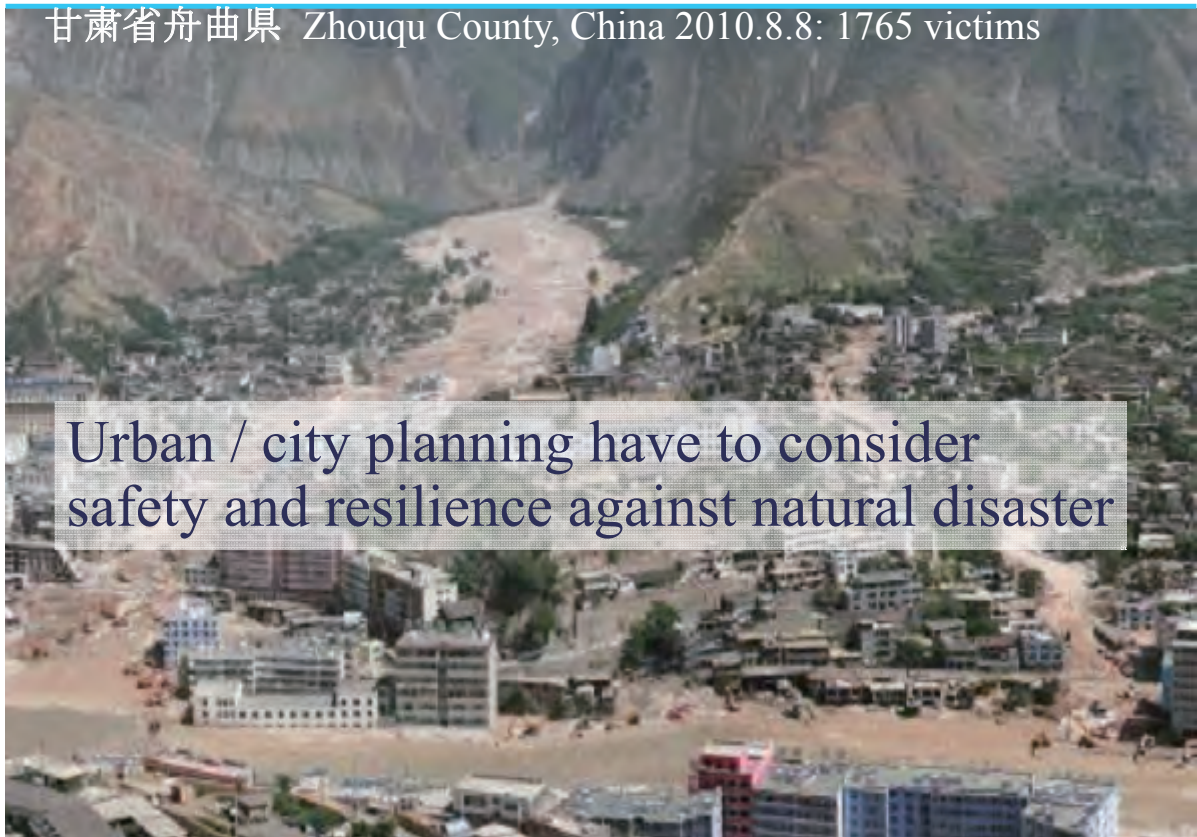
甘肅省舟曲県 Zhouqu County, China 2010.8.8: 1765 victims

Slope disaster caused by heavy rain:

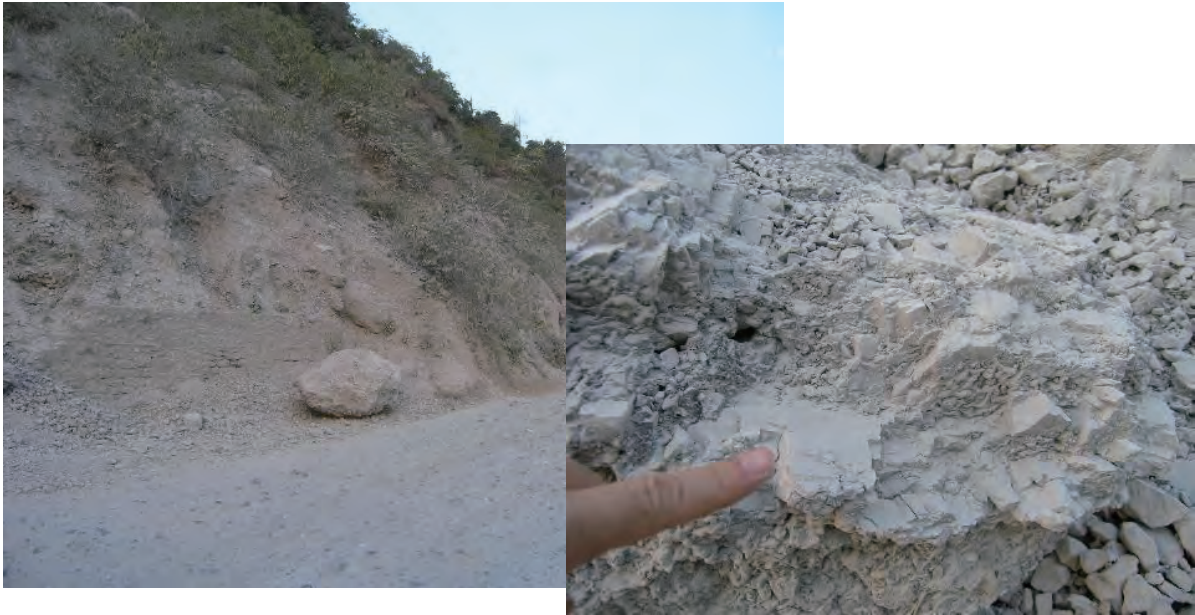
Weak geology in Nepal that I saw during my previous visit in 2012:

At Cohsmel between Pokhara and Lumbini;
Himalayan tectonic action has ruptured rocks

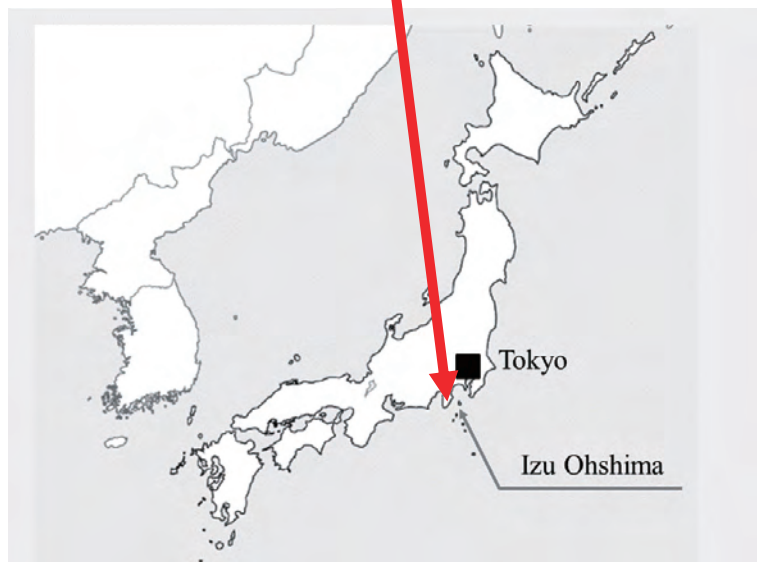
October 15-16, 2013

More than 800 mm in one night.

Rainfall concentrated in a small island → out of regional disaster warning.

Typhoon passed slowly near the island.

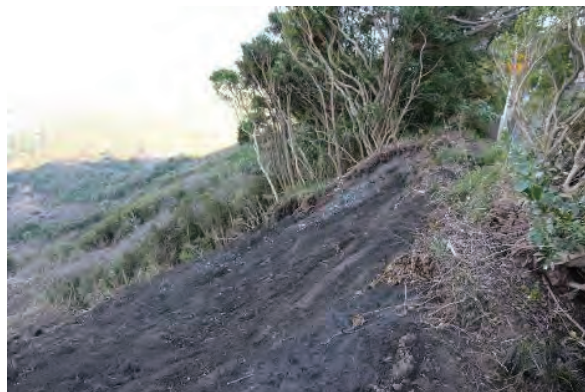
Initiated by shallow failures but evolved to a bigger size by erosion

Very thin failed layer

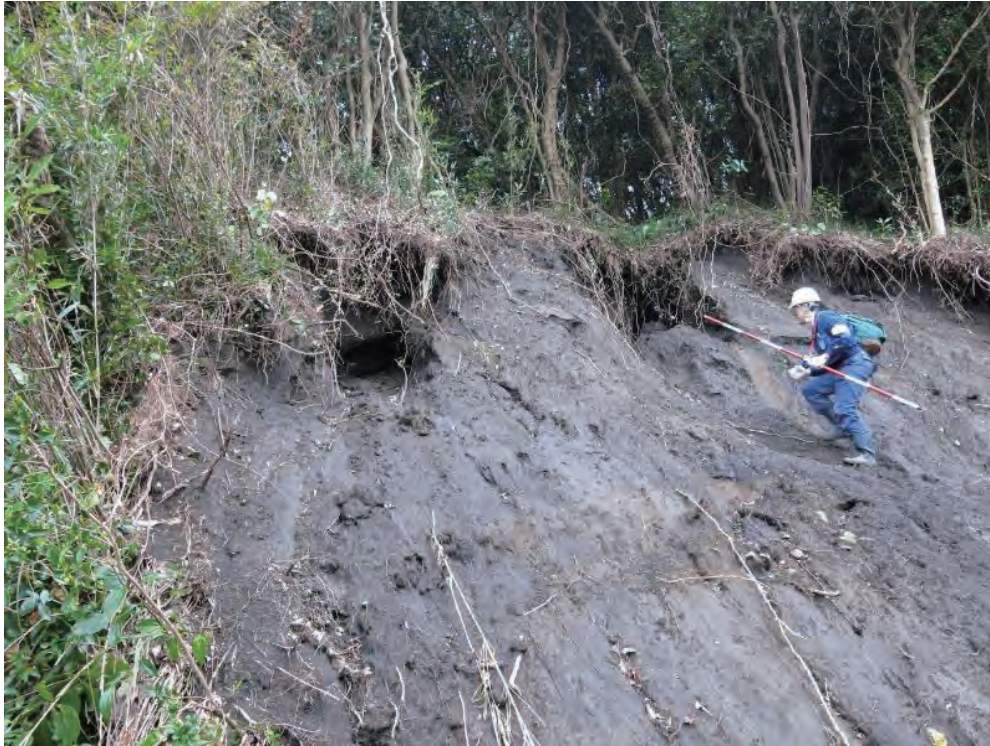
Piping holes: mechanism of slope failure?

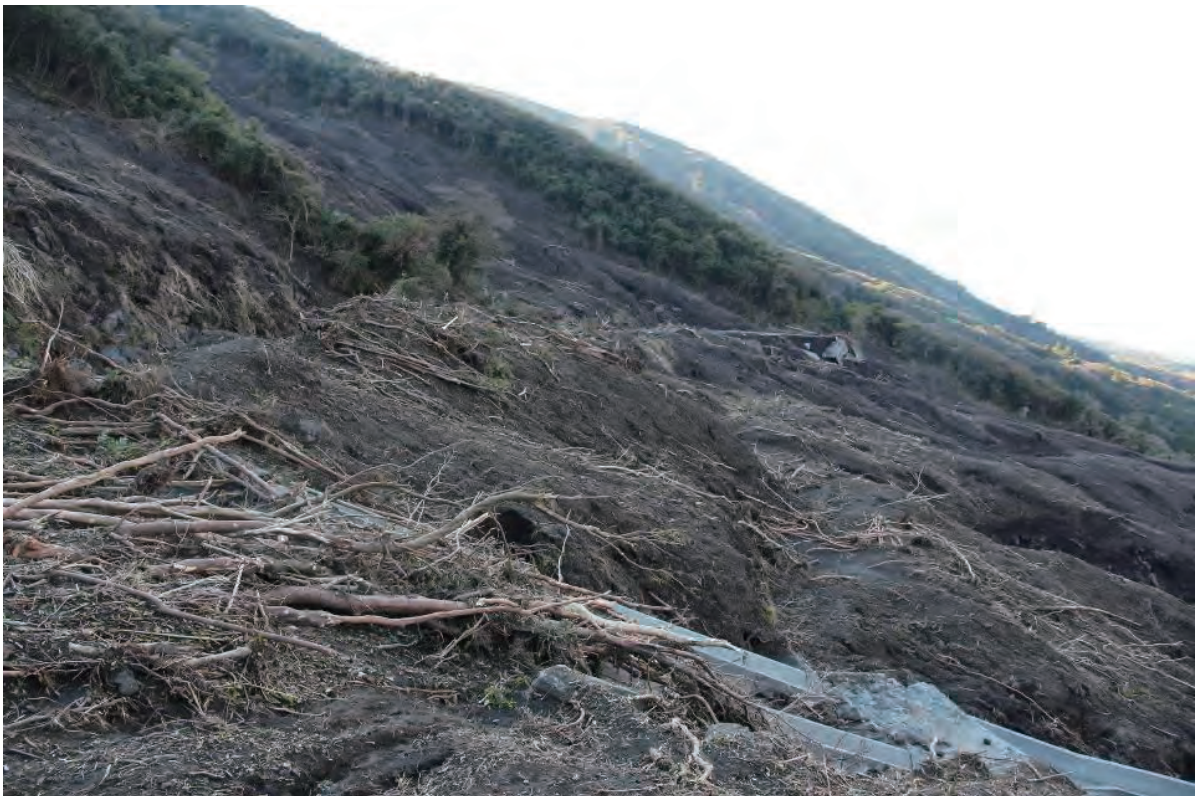
Erosion in the middle part of the slope
→ increased volume of soil flow

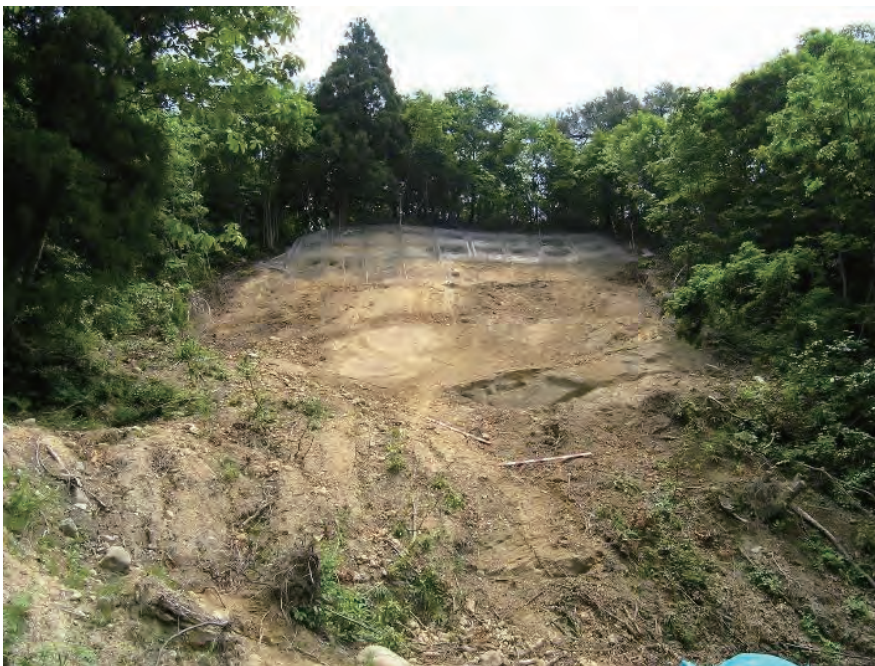
Monitoring displacement or else by
extensometers, GPS or else.

If displacement time history reaches some critical level, warning is issued for evacuation.

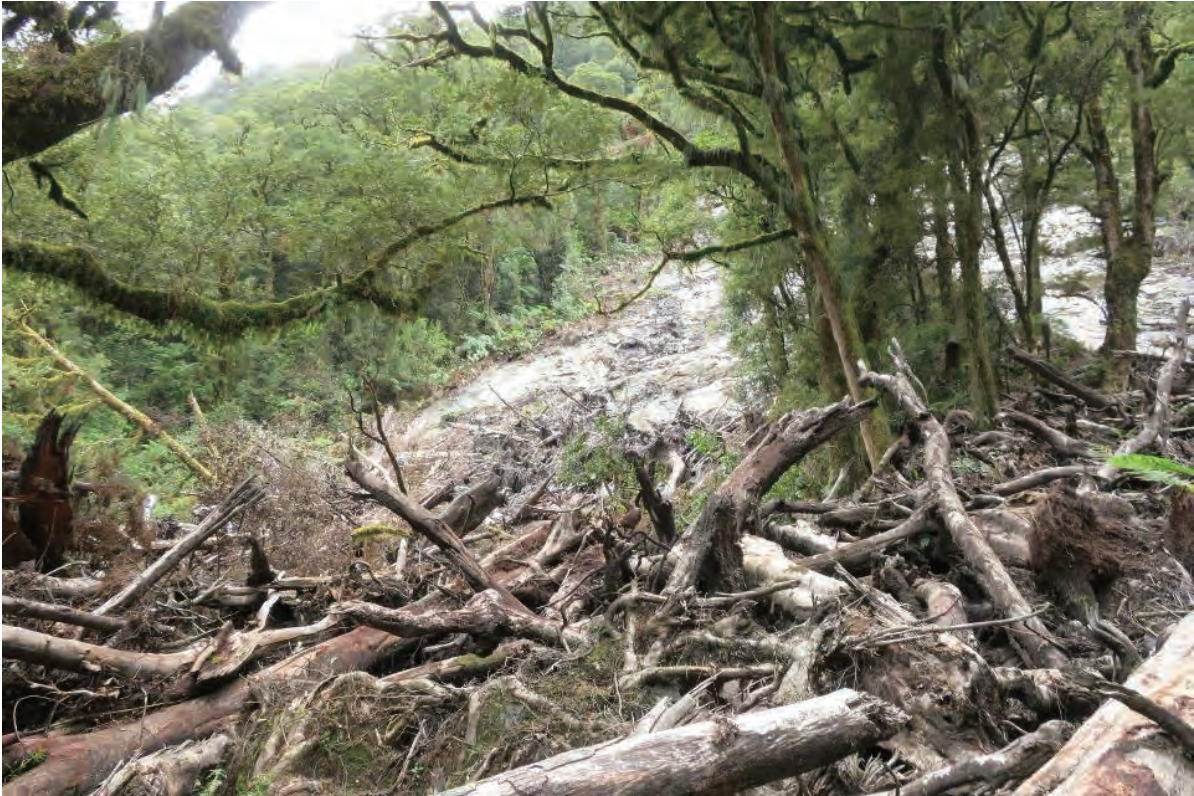
Kita-nigoro, Tochio, 2004

Sliding of
surface
weathered
material.

Small in
scale but
many in
number.

Where tree roots are shallow, the entire surface soil is lost during heavy rain.

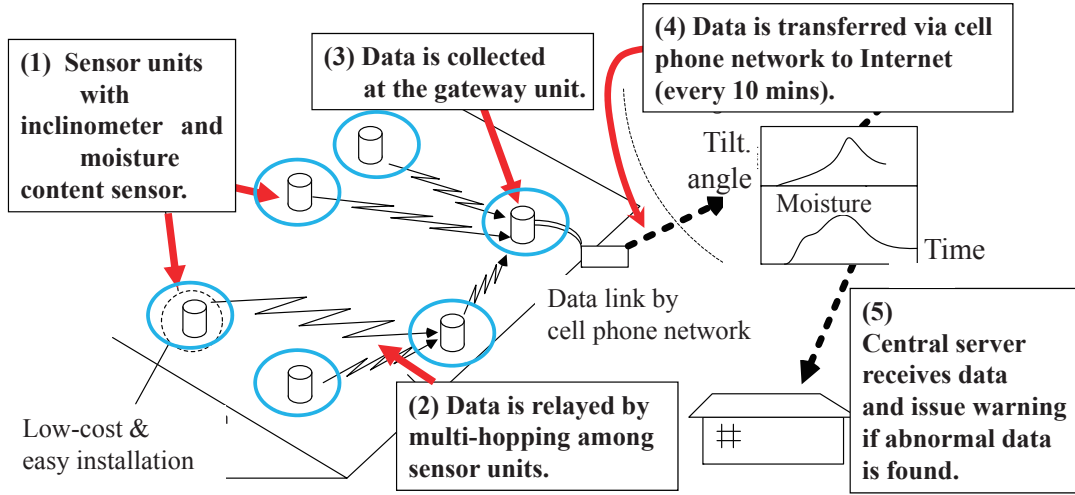
Fig. 1 Structure of the proposed wireless monitoring and early warning system

Many inexpensive sensors cover a slope.

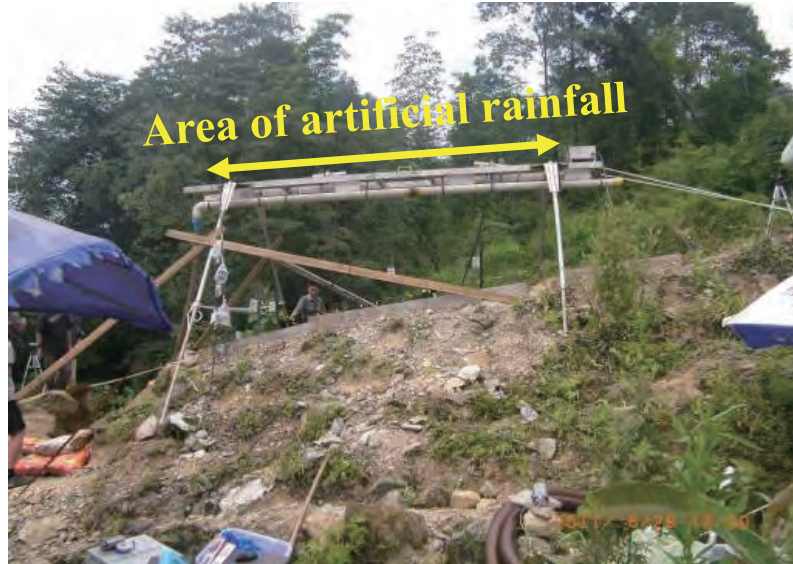
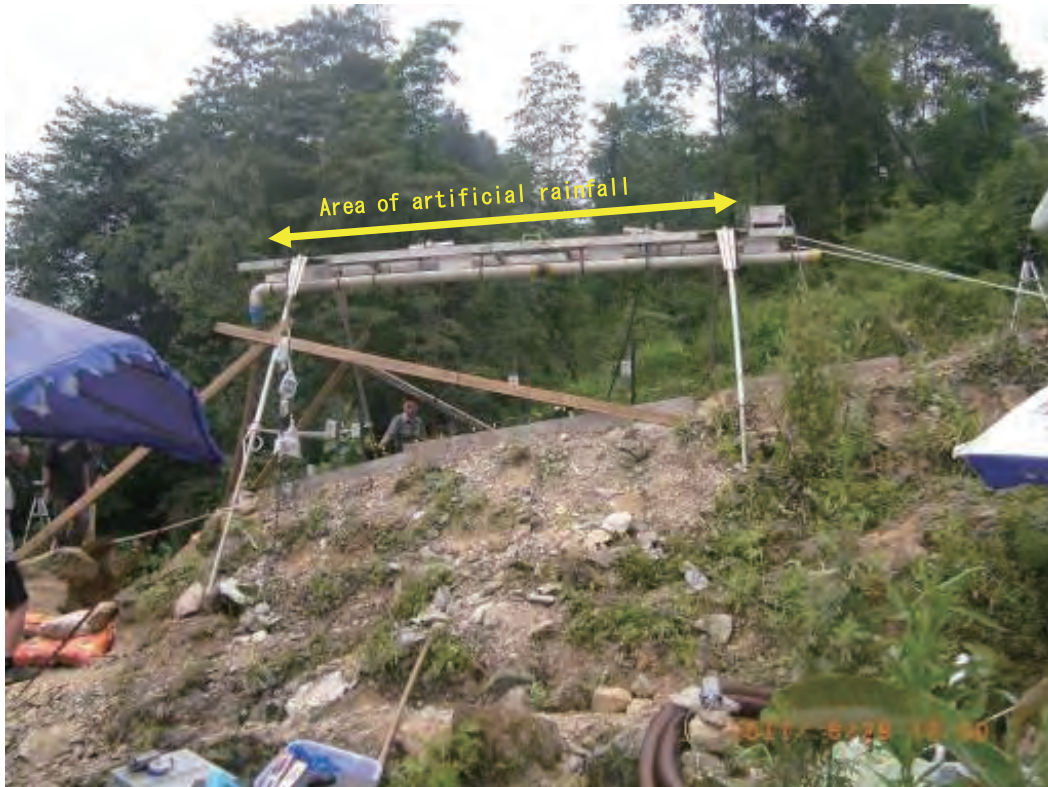
Artificial
rainfall test in
Sichuan
Province, China

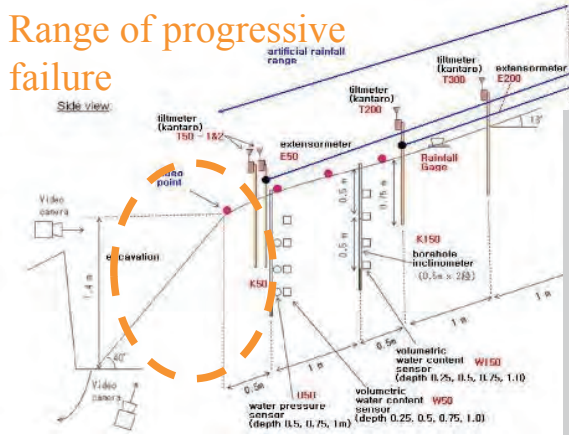
Range of progressive failure

Tilting rate between 3 and 10 deg/day in failure zone = 0.12 and 0.4 deg / hour

Caution if > 0.005degree / hour & Alert / Evacuation if > 0.1 deg/hour.

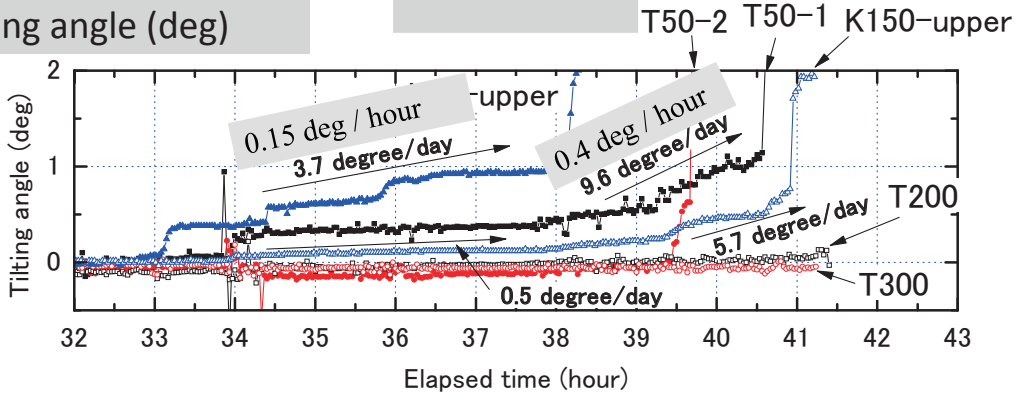
Tilting angle (deg)

Tilting angle * length of vertical rod = lateral displacement. It is **equivalent with** the data from a conventional (more expensive) **extensometer**.

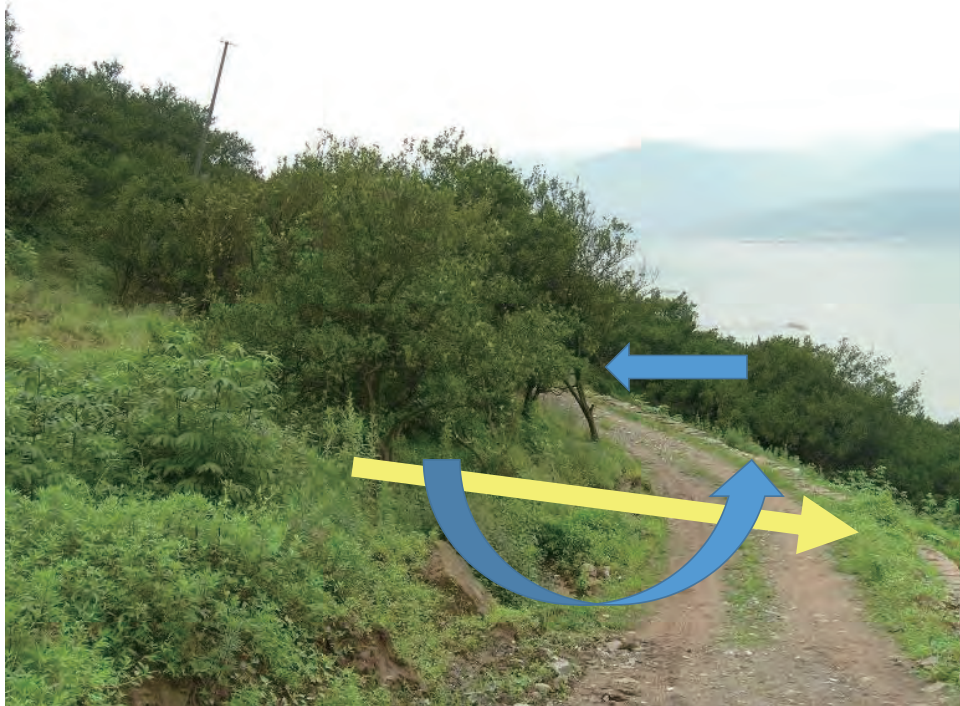
Along Three Gorge Dam Reservoir, China, many landslides were going on during filling water.

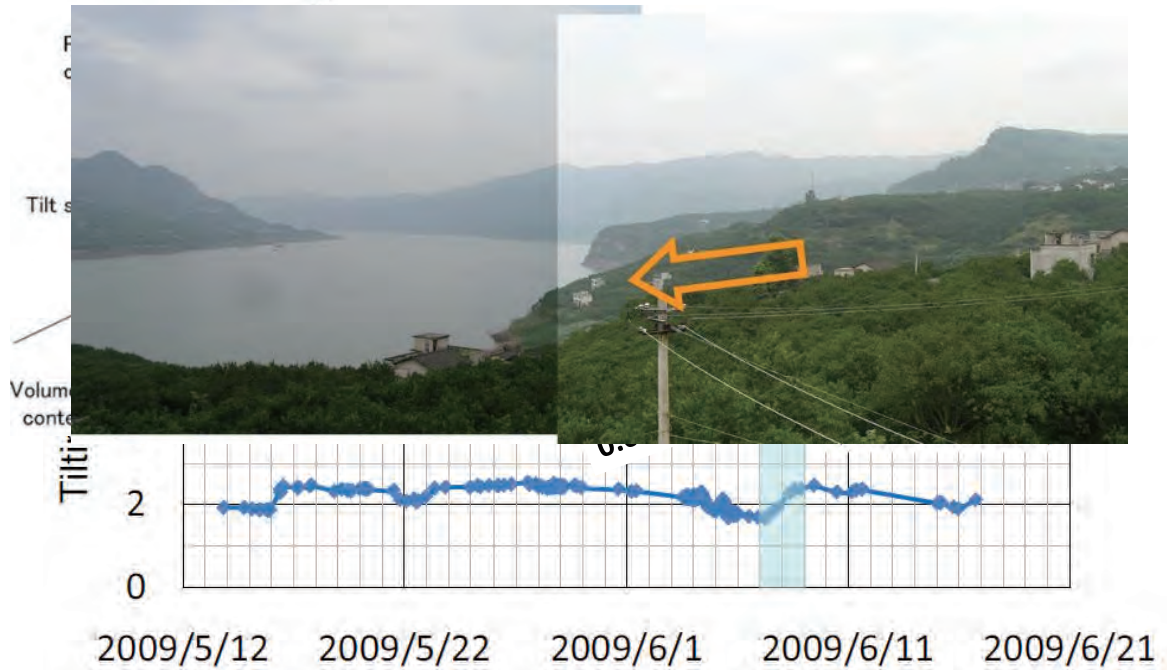
Monitored tilting angle in Three Gorges Dam Landslide Area

Current proposal: **Caution** if rate of angle > 0.005 degree / hour &
Alert / Evacuation if > 0.1 deg/hour.

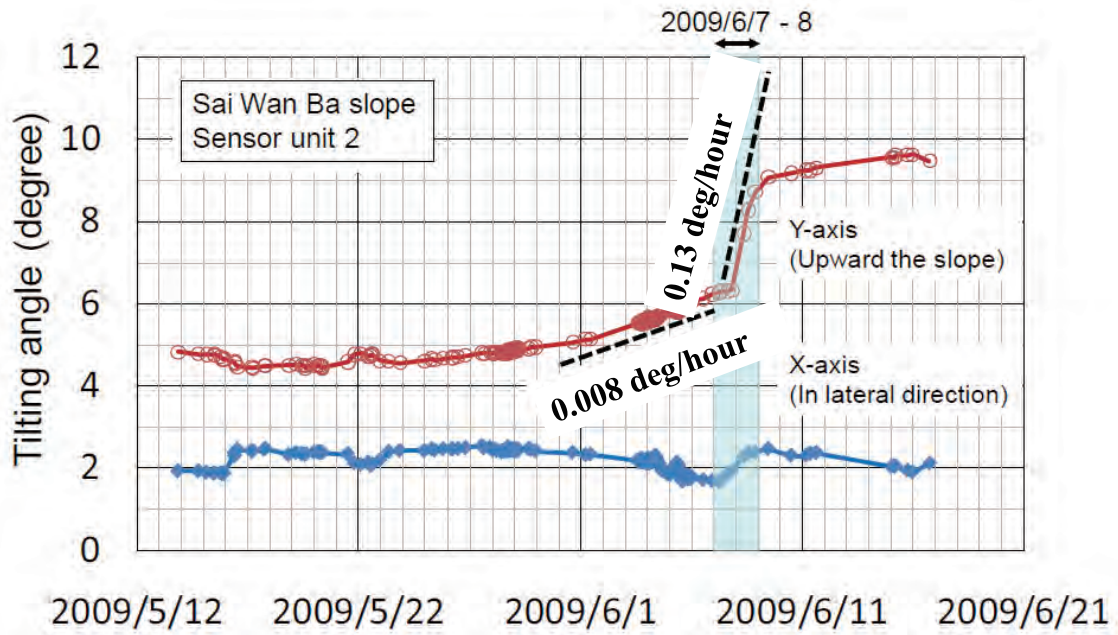
Monitored tilting angle in Three Gorges Dam Landslide Area

Current proposal: **Caution** if rate of angle > 0.005 degree / hour &
Alert / Evacuation if > 0.1 deg/hour.

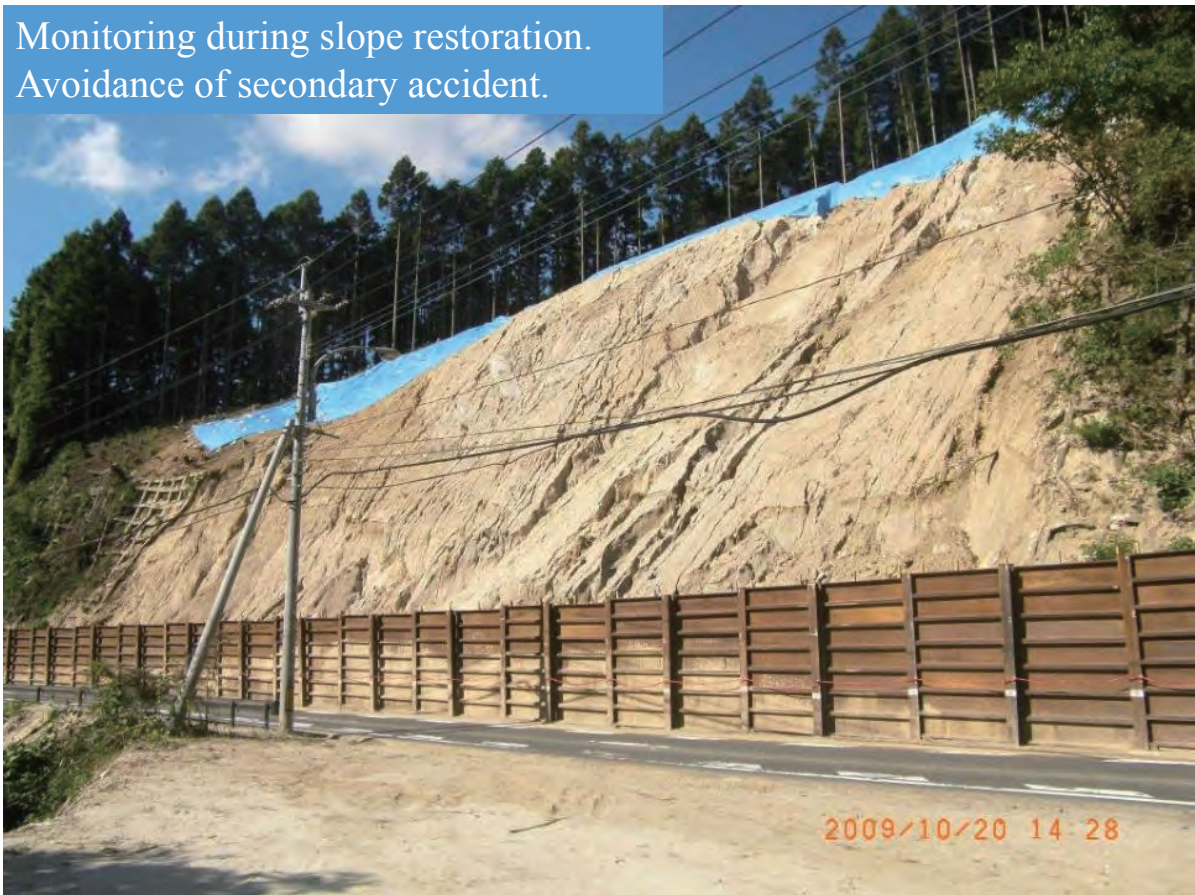
Monitoring during slope restoration.
 Avoidance of secondary accident.

After the first failure in July 2009:

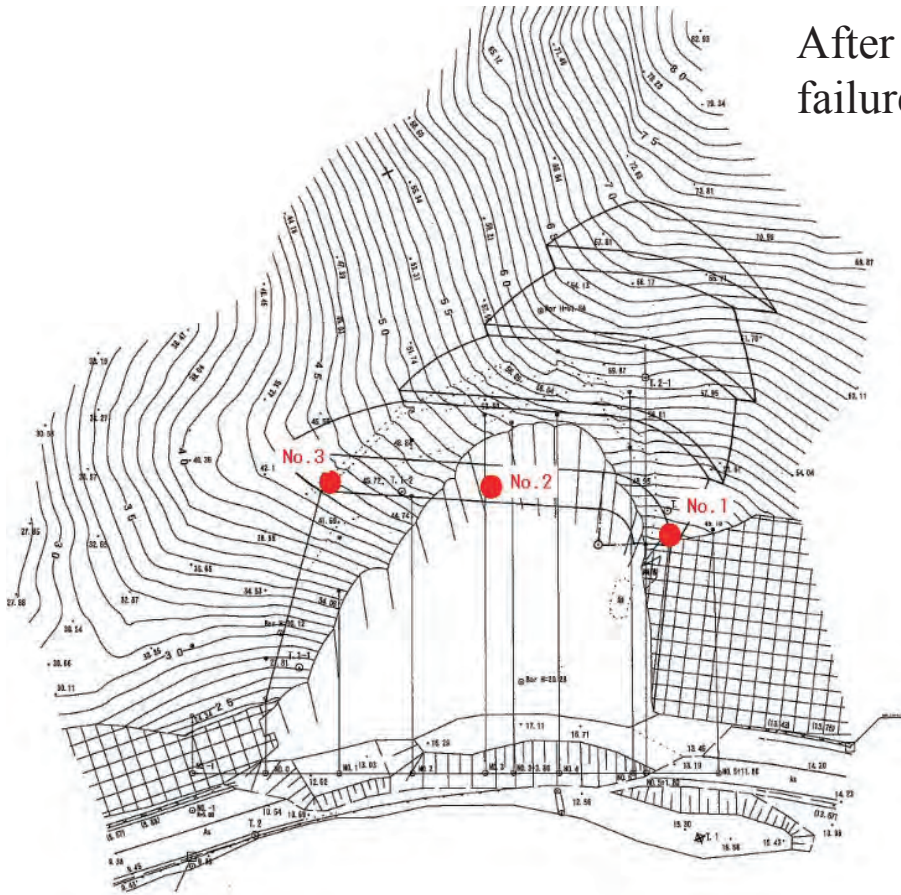
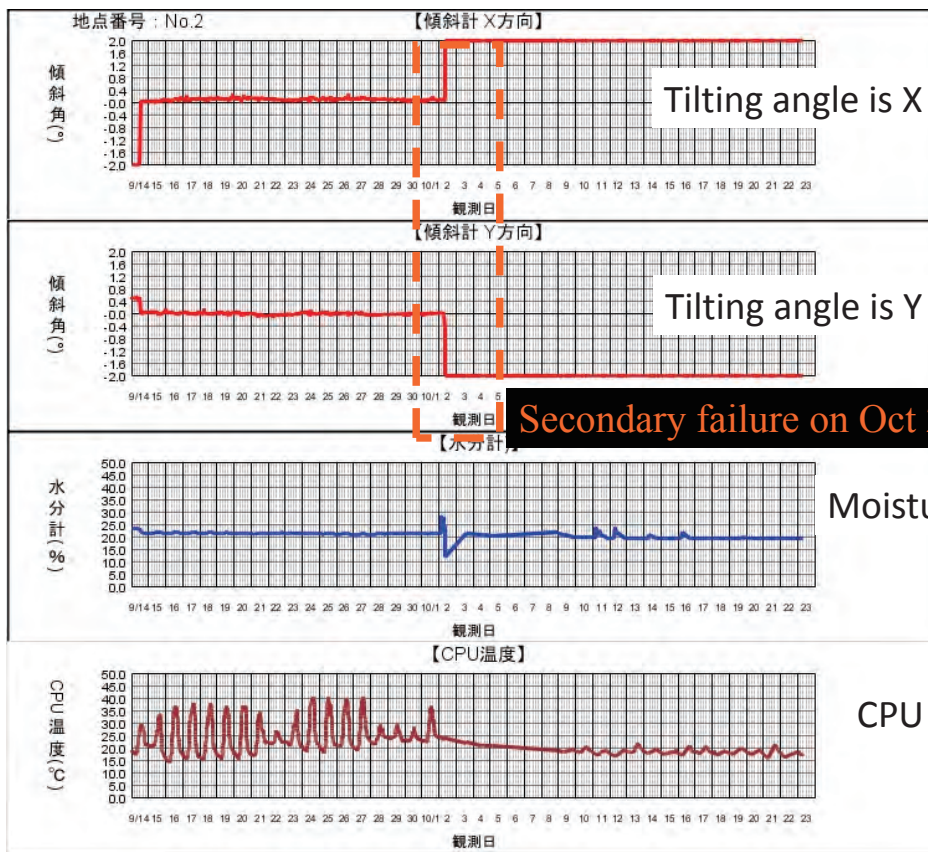
Tilting angle is X Direction

Tilting angle is Y Direction

Secondary failure on Oct 2.

Moisture content

CPU temperature

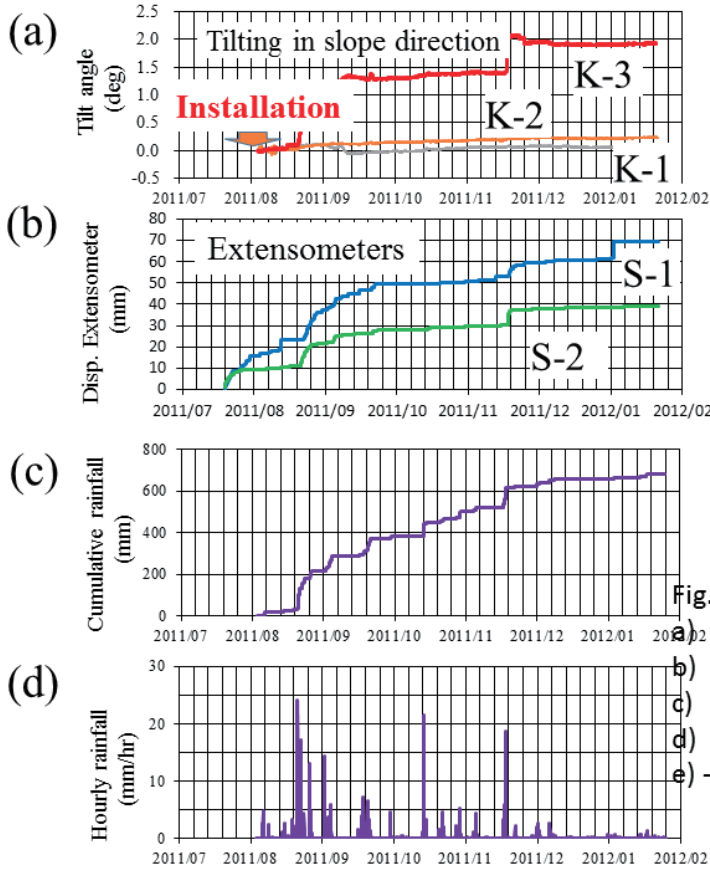
Fig. 18 Time histories of monitored items:

Extensometers started recording on Jul. 19, while tilt sensors started recording on Aug. 3.

- a) Tilt angles by surface tilt sensors;
- b) Displacements by extensometers;
- c) Accumulated amount of rain;
- d) Rainfall intensity;
- e) - h) Zoom up for heavy rainfall events.

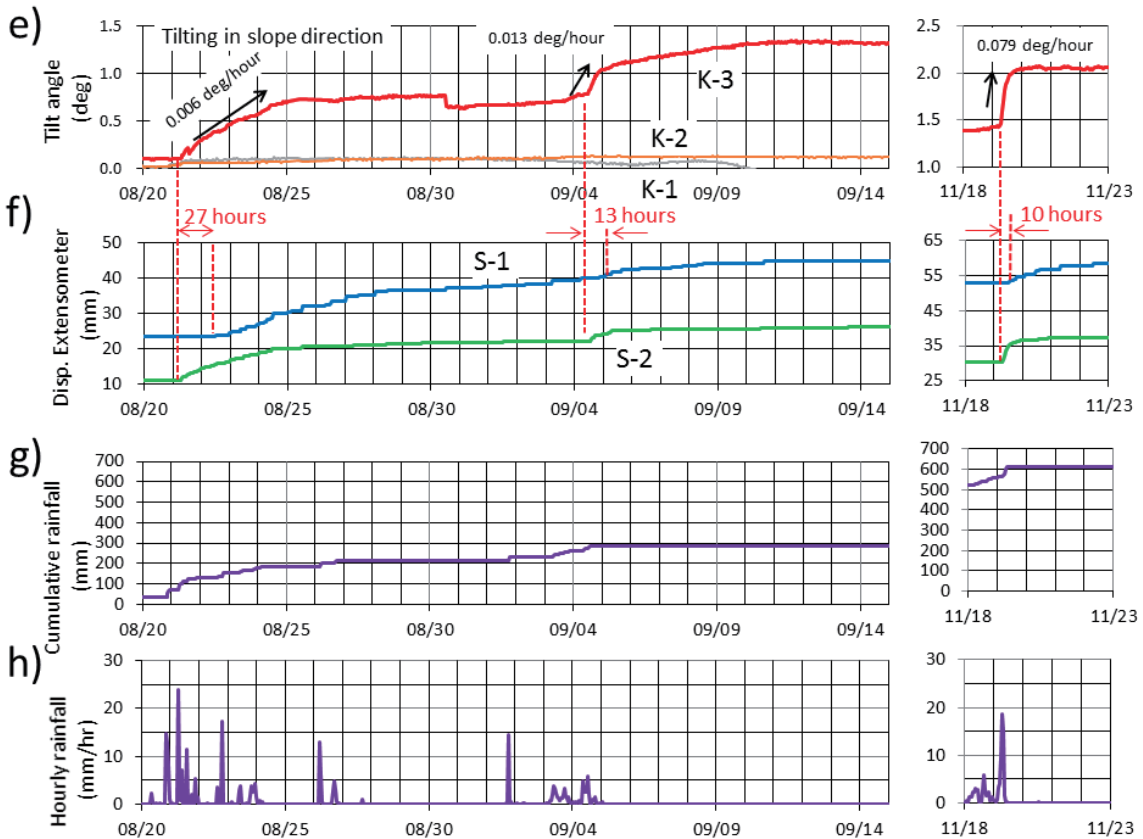
Tilting angle, K-3 (deg)

Extensometers started recording on Jul. 19, while tilt sensors started recording on Aug. 3.

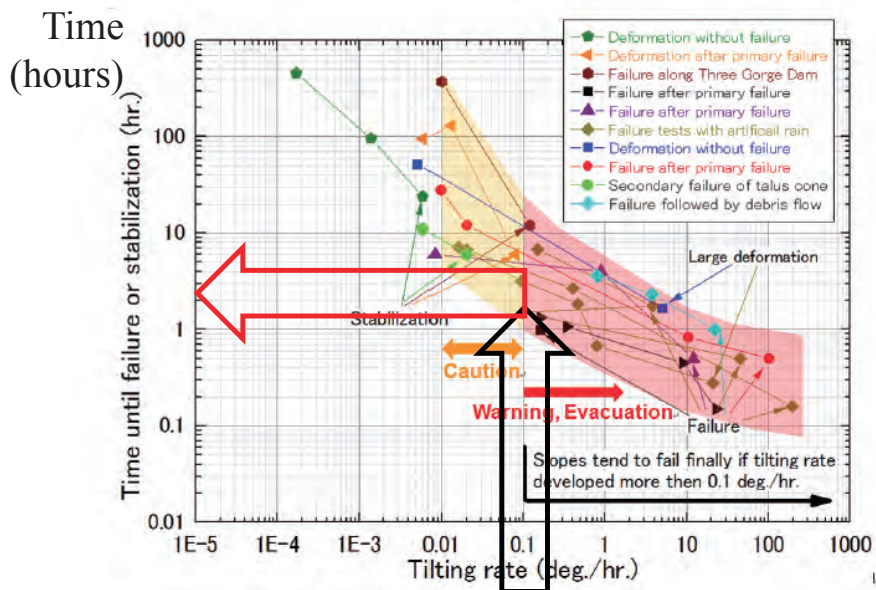
Relationship between monitored **rate of tilting** and time until final failure

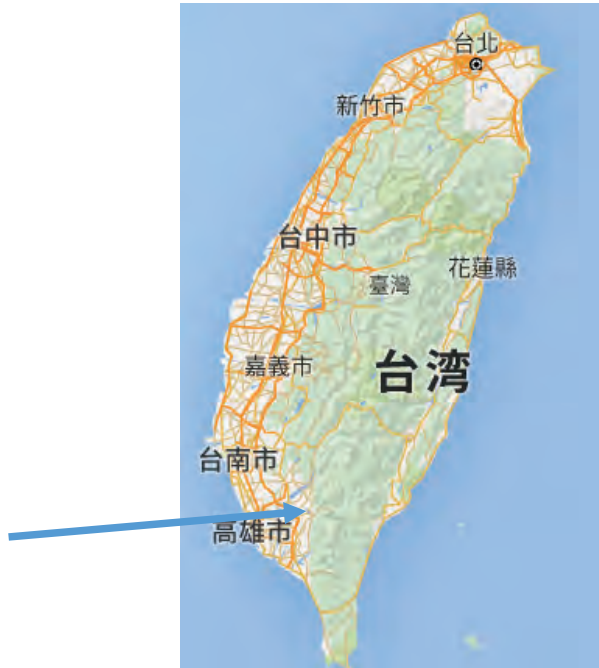
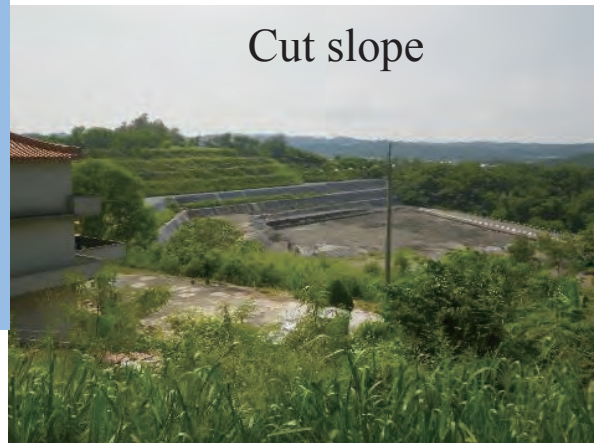
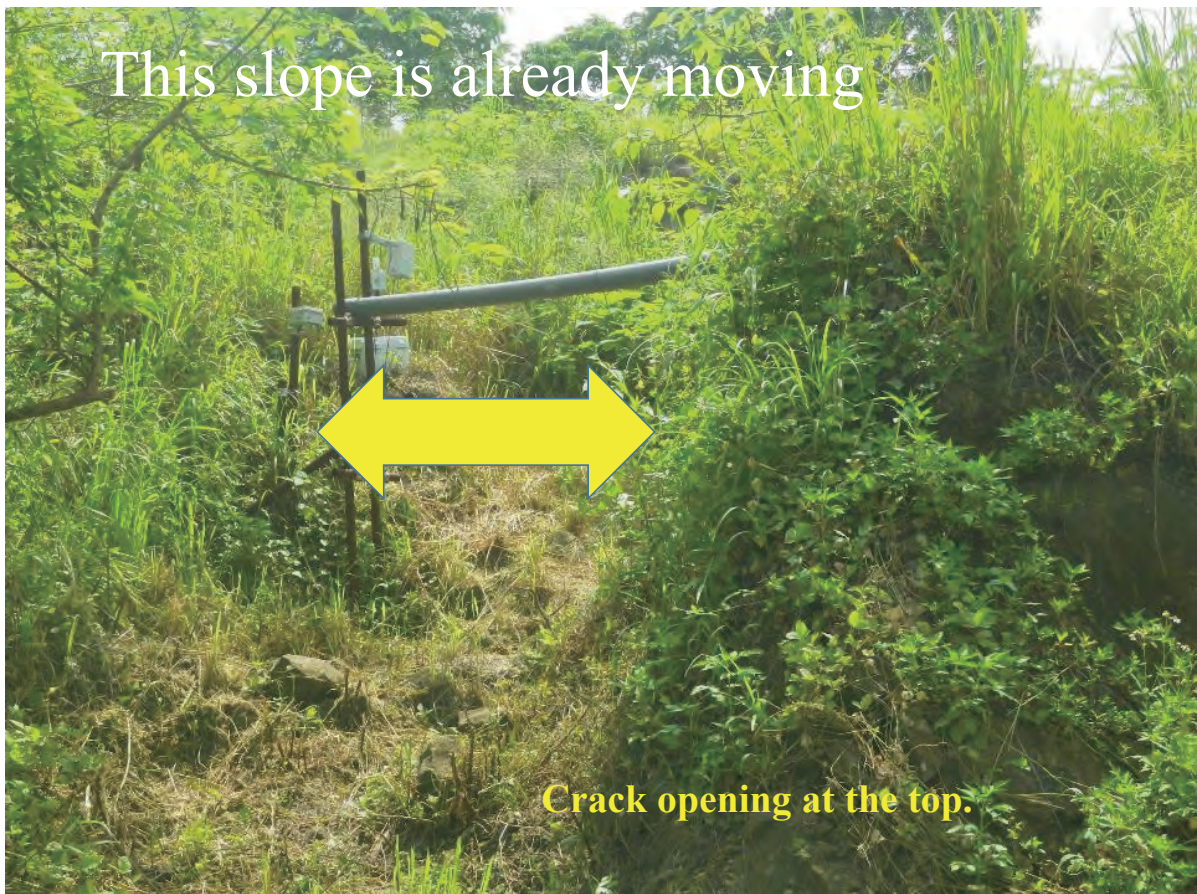
Attempts for multi-point monitoring (in Taiwan)

Records of tilting angle in X and Y directions

Rainfall record May 2015

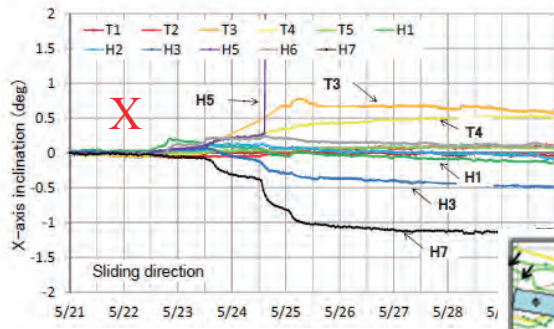
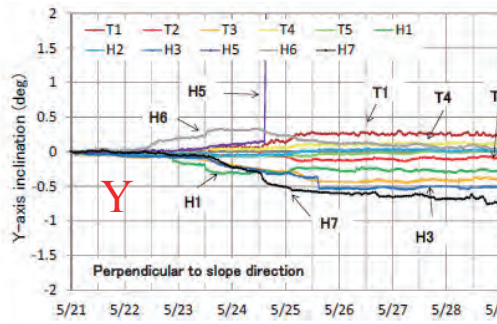
No failure

Monitoring of unstable stones

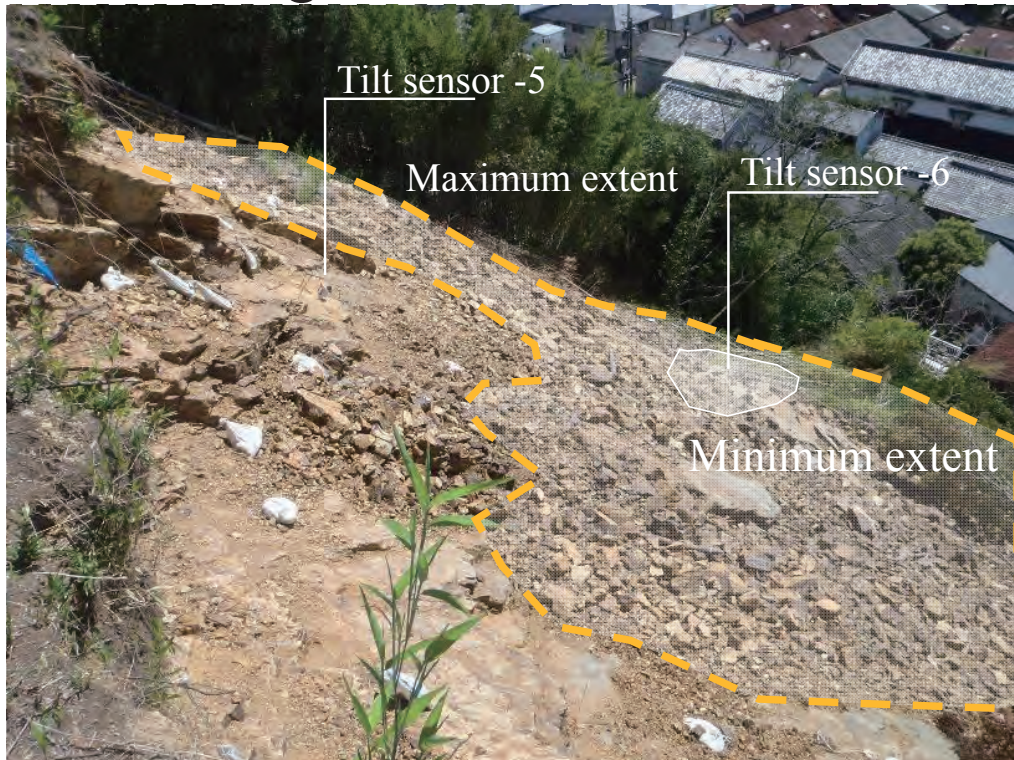
Basic mechanism of slope failure

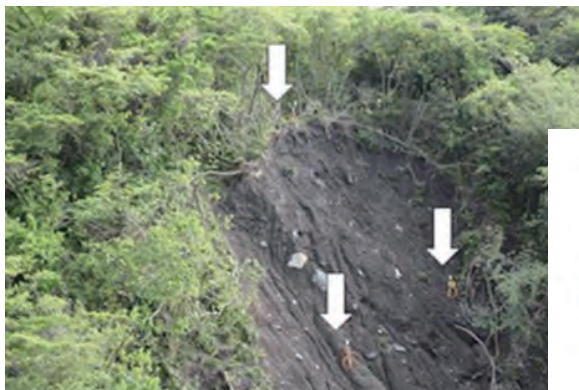
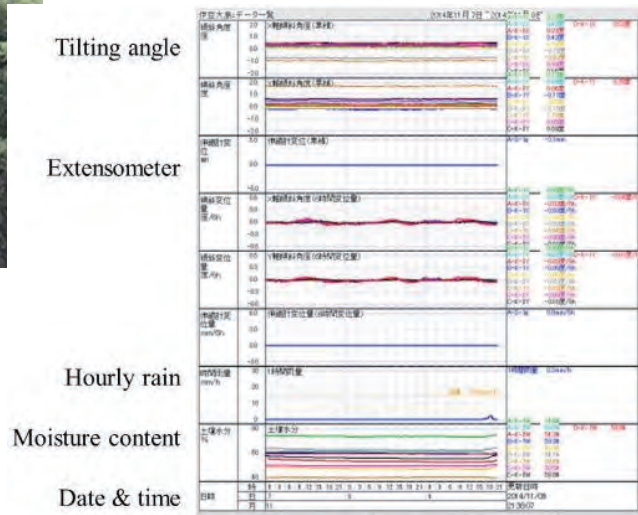
Izu Oshima again

Tilting angle was monitored in a very unstable slope but nothing happened.

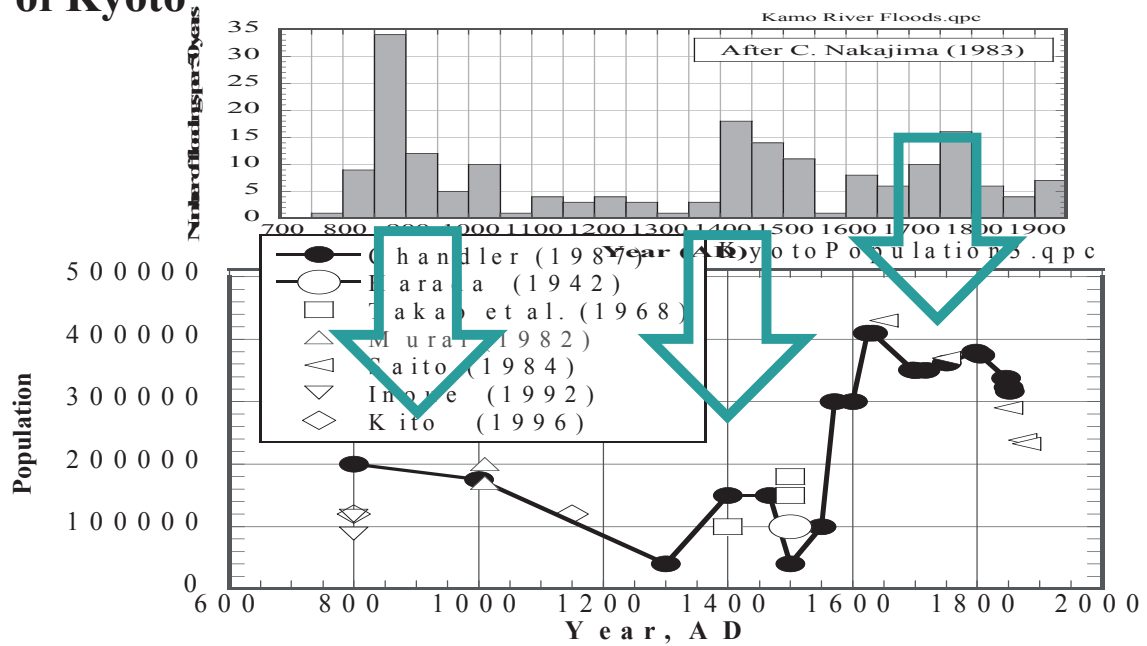
Correlation between Kamo river flooding and population of Kyoto

Better correlation.
People cut down trees in mountains and increased the risk of flooding.
